Evaluation Report 18

New Holland Model 850 Round Baler

New Holland Model 850 Round Bale

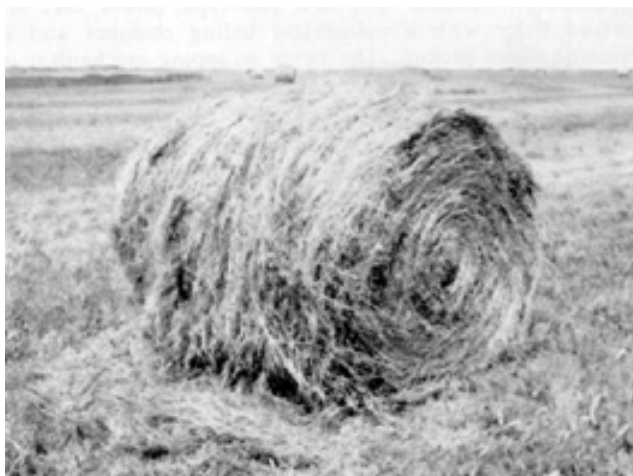
Figure 4. Typical Bales Formed by the New Holland 850.

Bale Quality: The New Holland 850 produced firm bales (Figure 4) with a shaggy appearance. Bales generally, did

not have a uniform diameter throughout their length but had fairly flat ends. Bales averaged 1.7 m (68 in) in length and 1.7 m (68 in) in diameter. Average hay bales weighed from 705 to 865 kg (1530 to 1905 lb) with an average density of 192 kg/m³ (12.0 lb/ft³). Density was uniform throughout the bale.
